How to pull the rear cap to repair basement air ducting

An article by Don Winyninger

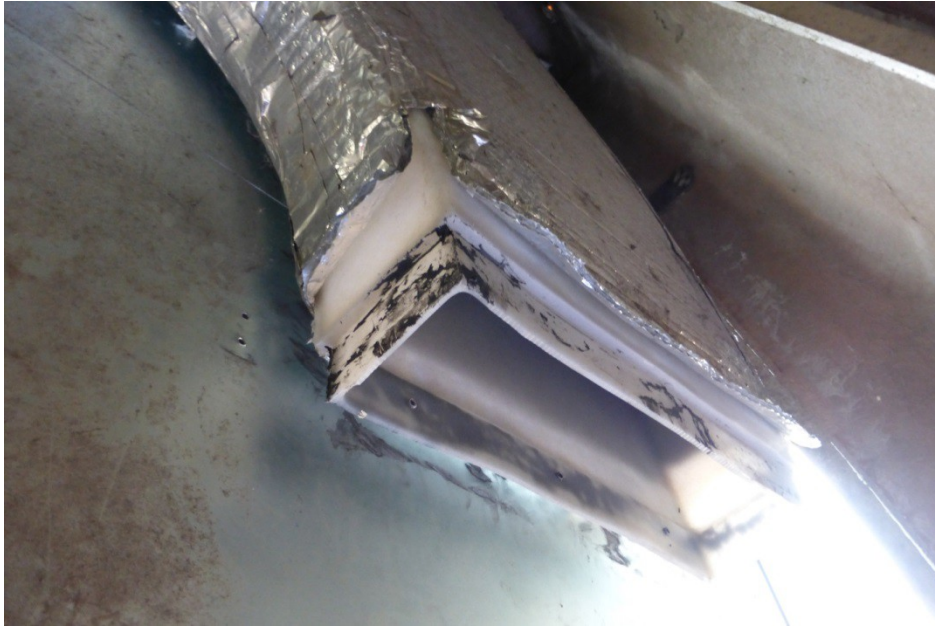
The upper wye is molded plastic, like the elbow that is attached to the heat pump, so it won't fail. It's the straight section between these two plastic pieces that comes apart. This straight section is made of ductboard which is attached to the upper wye with black mastic and 10 screws. The screws on the back of the duct are difficult. Don't pull the upper wye out too much or you'll tear the upper connections loose. A small right angle screwdriver worked for me.

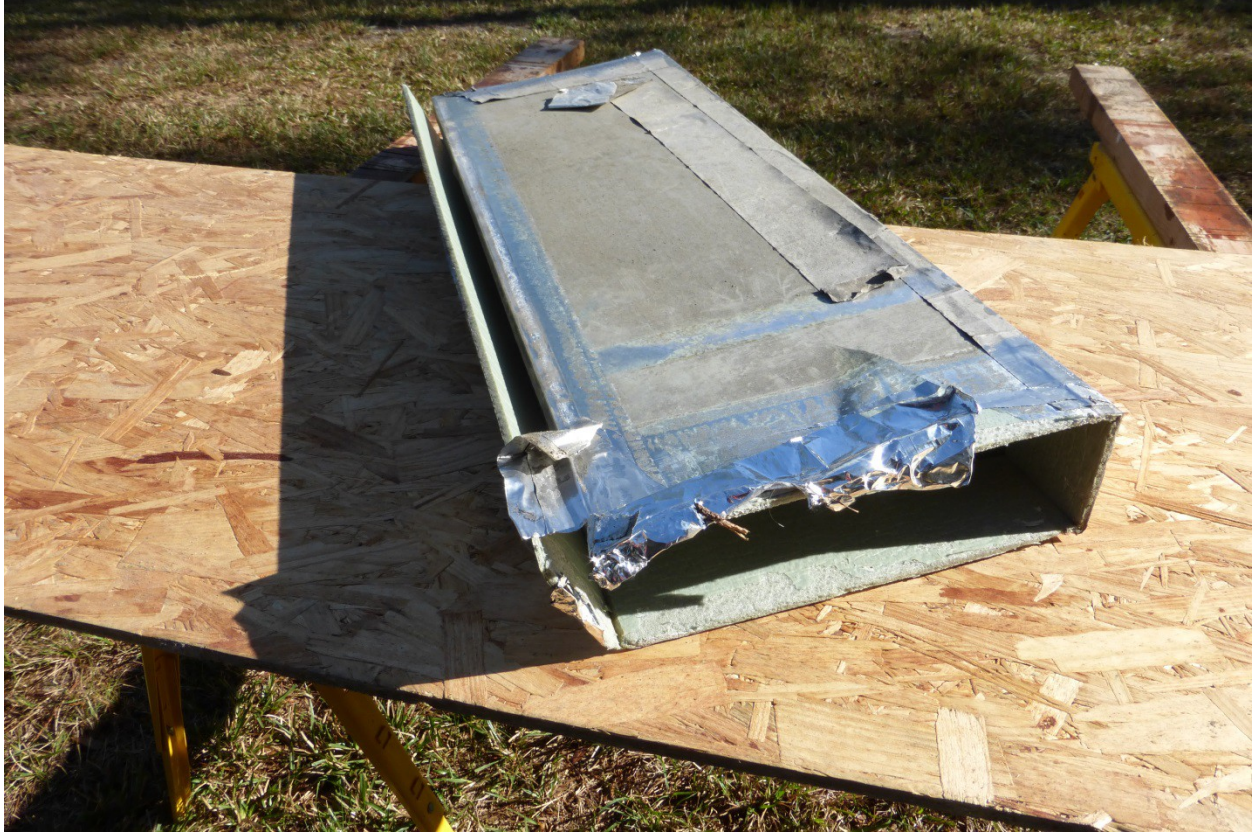
Isn't this lovely? All I had done to this point was remove the duct. The only thing holding it together was the tape at each end where it connected to the plastic plenums. The tape along the joint fell off while I was removing the duct.

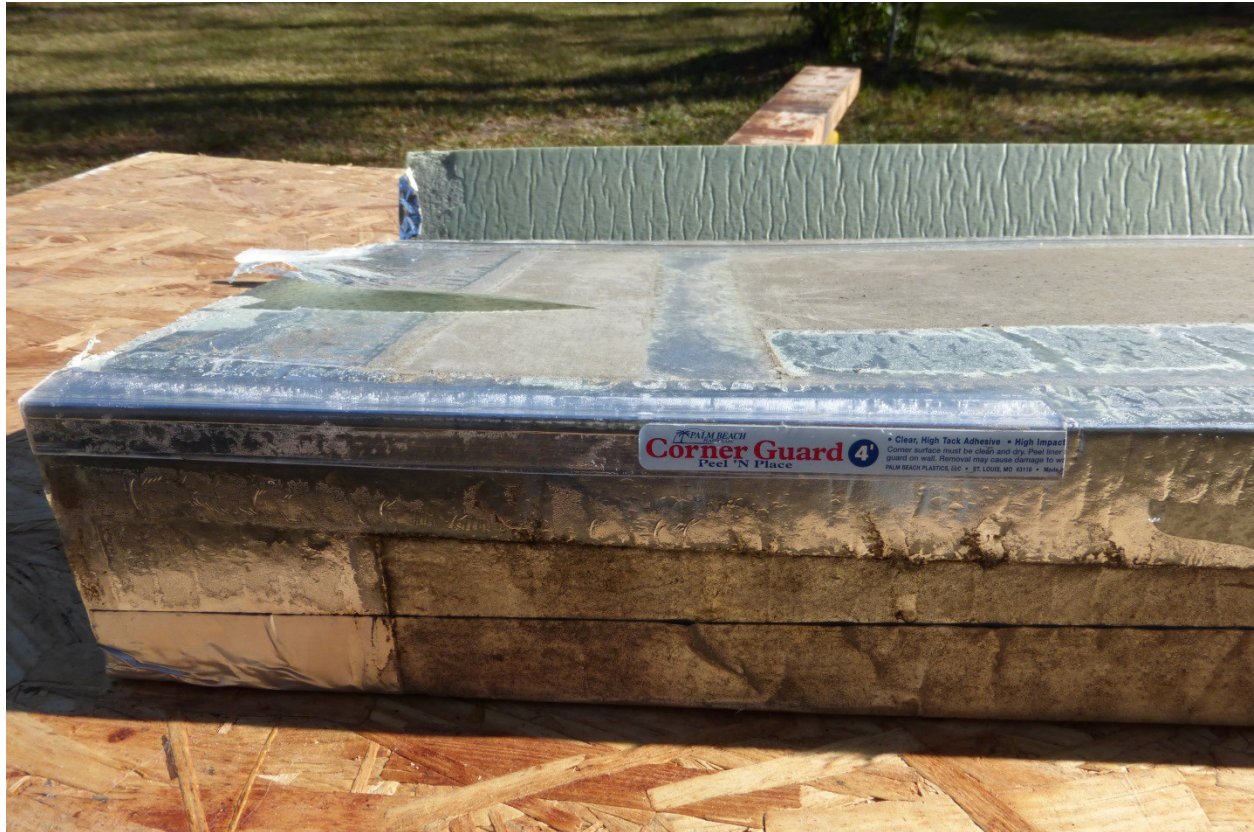
This is what is used to “reinforce” the corner joint. This photo shows the left over 12” piece that was randomly placed on one edge. The “Corner Guard” comes in 4’ lengths and since the duct is only 36” long they have a 12” piece of scrap to discard, so they just stick it somewhere. This “Corner Guard” is a product intended to protect the corners of the interior walls of your house. It is not well suited to hold a duct together.

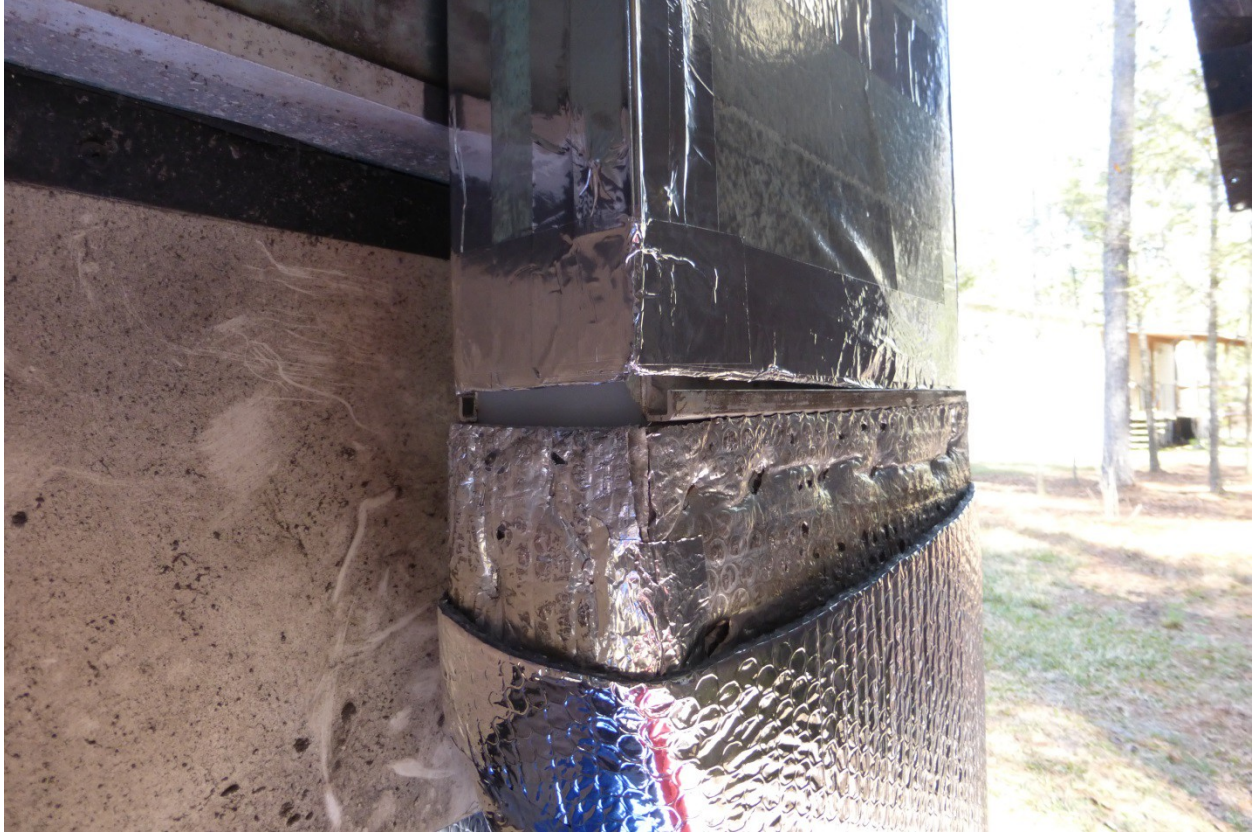
After I had the upper connection done and reinstalled the lower elbow plenum I saw that the lower connection was not square; about a $\frac{3}{4}$ " gap at one end. This is the misalignment I mentioned earlier. I just used extra tape to cover the gap. I figure that if it fails it's at the bottom and can be easily reached. I did not use screws at this joint since it is basically held in place by compression.

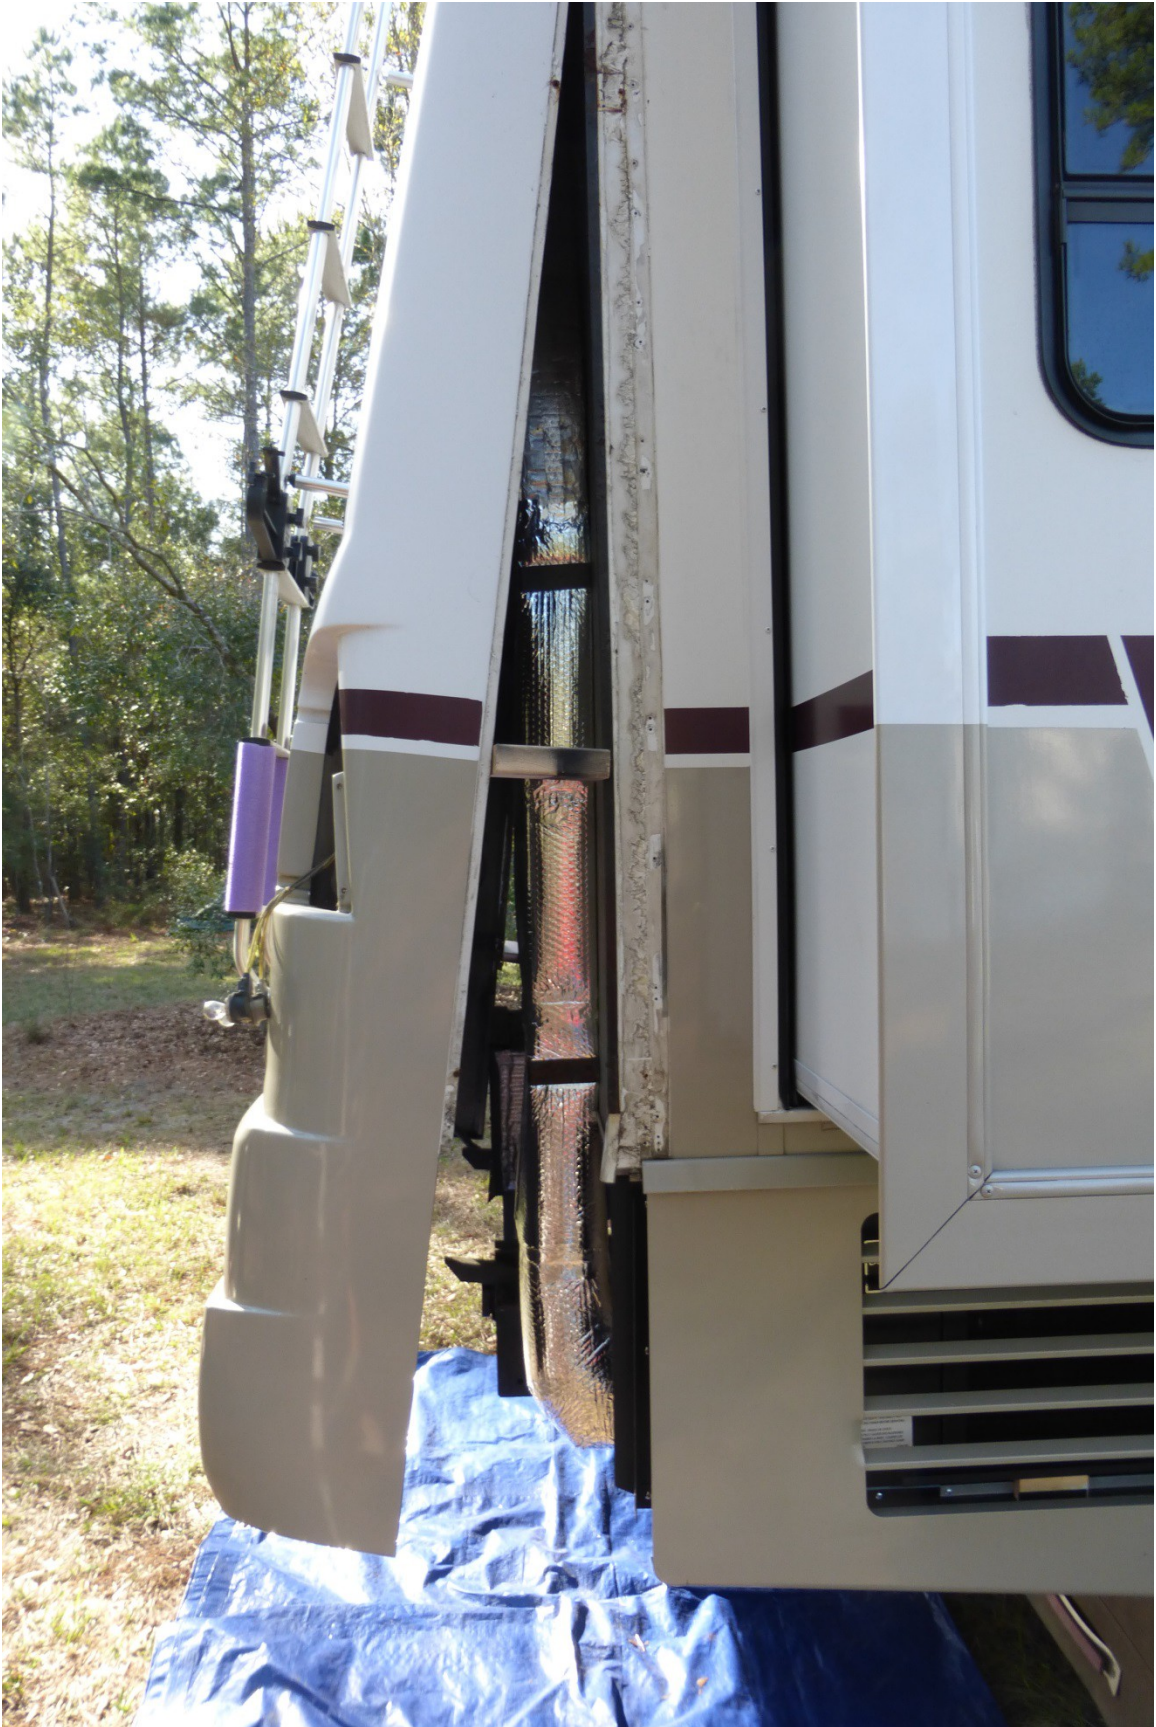
A side view which shows how much I pulled the cap out.
